We Dried Out a **ZOO!**

Story and photos by Ken Larsen, CR WLS

[Editor's Note: This project illustrates the value of RIA membership and was a joint effort between several member contractors. Rocky Cross Construction (North) Ltd. of Calgary, Alberta, was the general contractor, Drytech International was the drying sub-contractor that provided the specialized equipment, and Ken Larsen, CR, WLS, of the International Dry Standard Organization (and an RIA CR/WLS instructor) was retained by Drytech to manage the specialty drying portion of the project.]

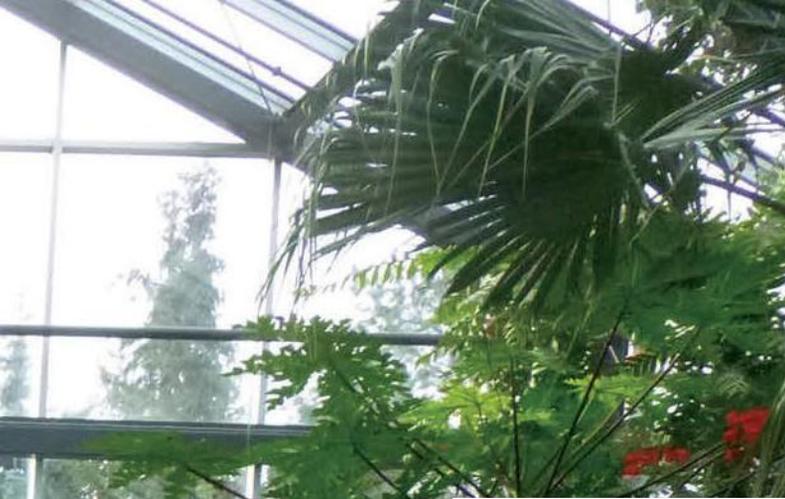
The Butterfly Room was particularly challenging because the lush plant life and butterflies needed to be isolated from the concrete floor drying strategy.

The slate tile floor was removed; the concrete slab required drying prior to tile replacement. The butterflies and plants could not be relocated and the room has a normal relative humidity of between 60 percent to 80 percent, so the concrete slab needed to be isolated from the ambient conditions with a tenting process.

While it was easy enough to inflate a tent in the room, it was necessary to evacuate the air from under the tent so that it wouldn't seep into the butterflies' atmosphere. This was accomplished by extending the tent to an open window on the opposite end through which the air could ventilate.

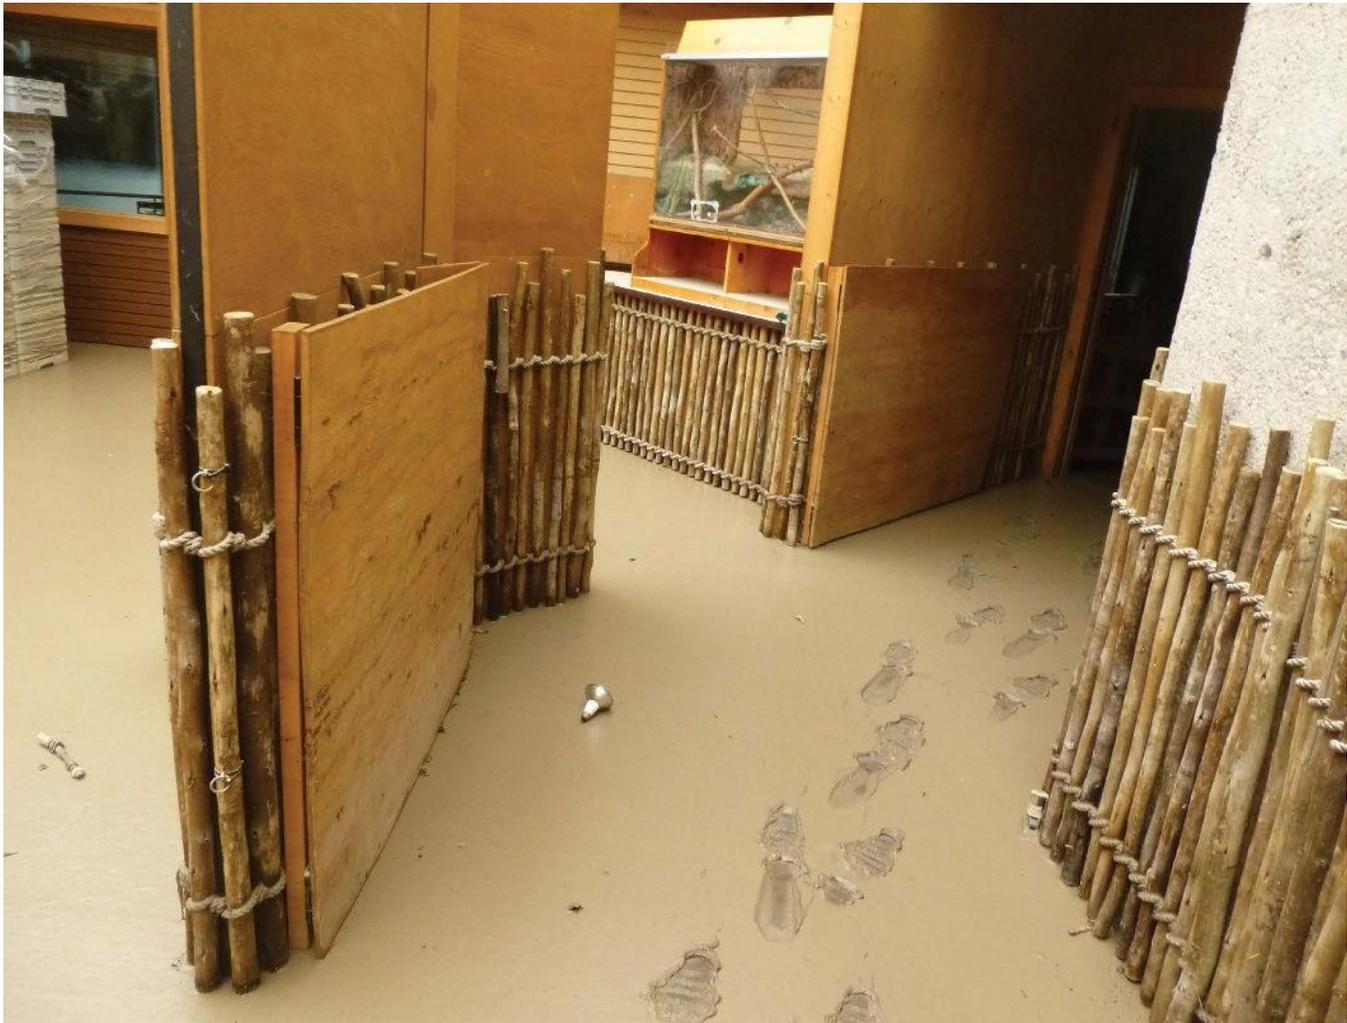
Hardwoods imported from South America had to be removed to dry and clean the Amazon exhibit.

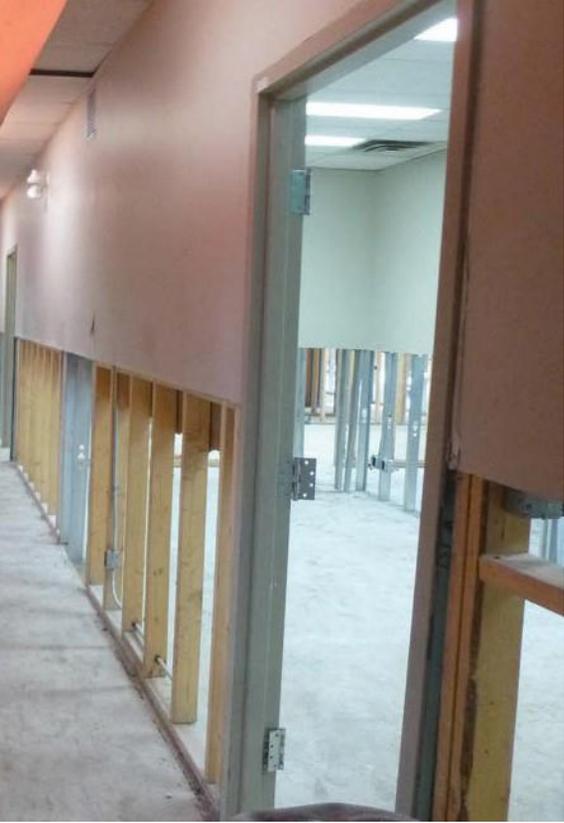
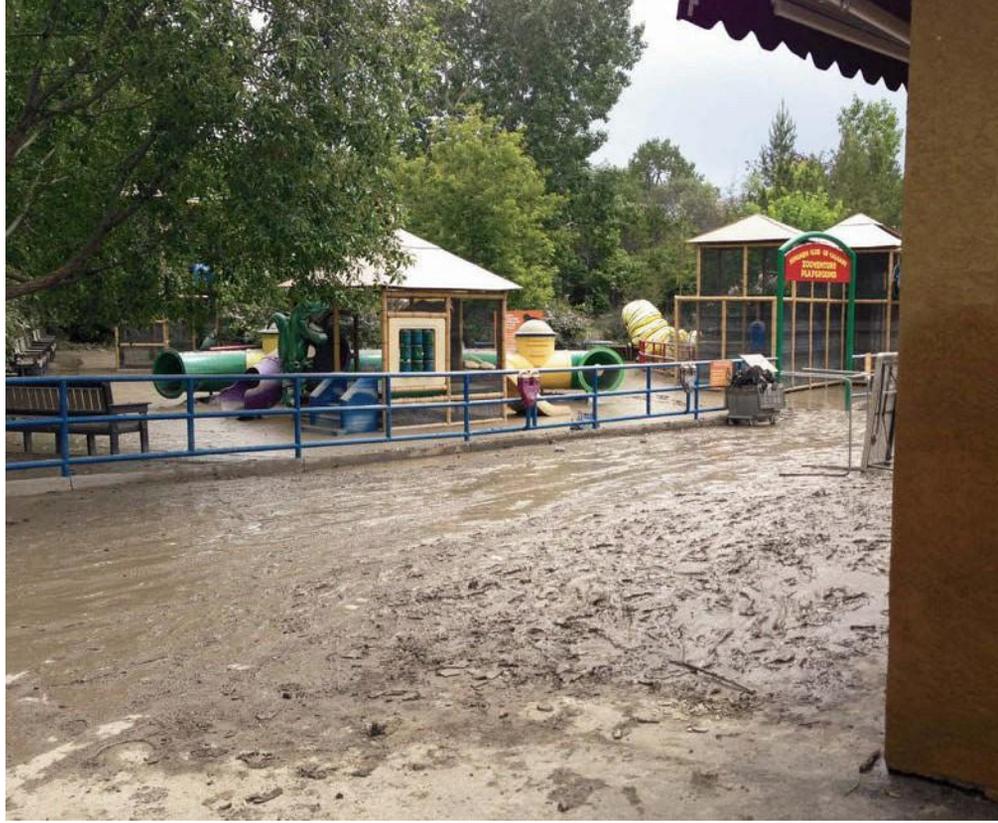
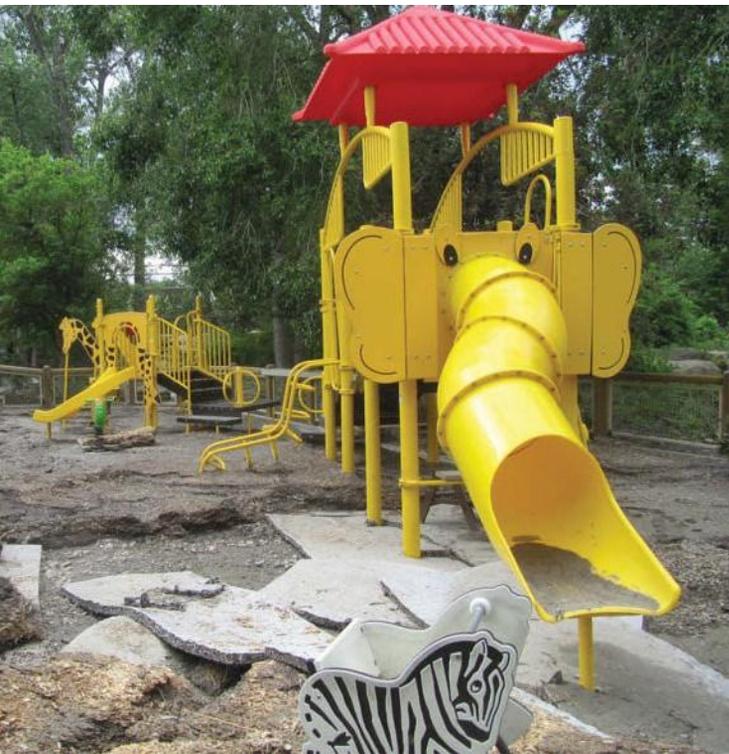
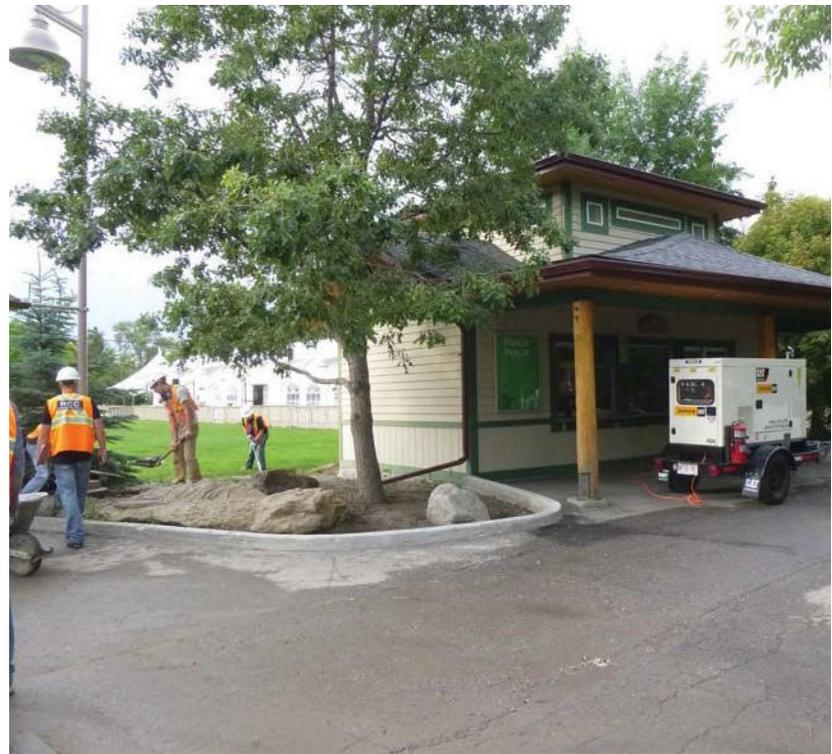
(Clockwise from top left) Animal cages were particularly challenging to isolate with effective containment. Decontamination protocols included containment and controlled deconstruction. Silt and muck from rising river water grossly contaminated areas that were sensitive to visitors. Temporary power was required for several isolated buildings ranging in size from this small concession stand to very large exhibit buildings. The children's playground suffered powerful erosion damage and Category 3 contamination.
