We Dried Out a **ZOO!**

Story and photos by Ken Larsen, CR WLS

[Editor's Note: This project illustrates the value of RIA membership and was a joint effort between several member contractors. Rocky Cross Construction (North) Ltd. of Calgary, Alberta, was the general contractor, Drytech International was the drying sub-contractor that provided the specialized equipment, and Ken Larsen, CR, WLS, of the International Dry Standard Organization (and an RIA CR/WLS instructor) was retained by Drytech to manage the specialty drying portion of the project.]

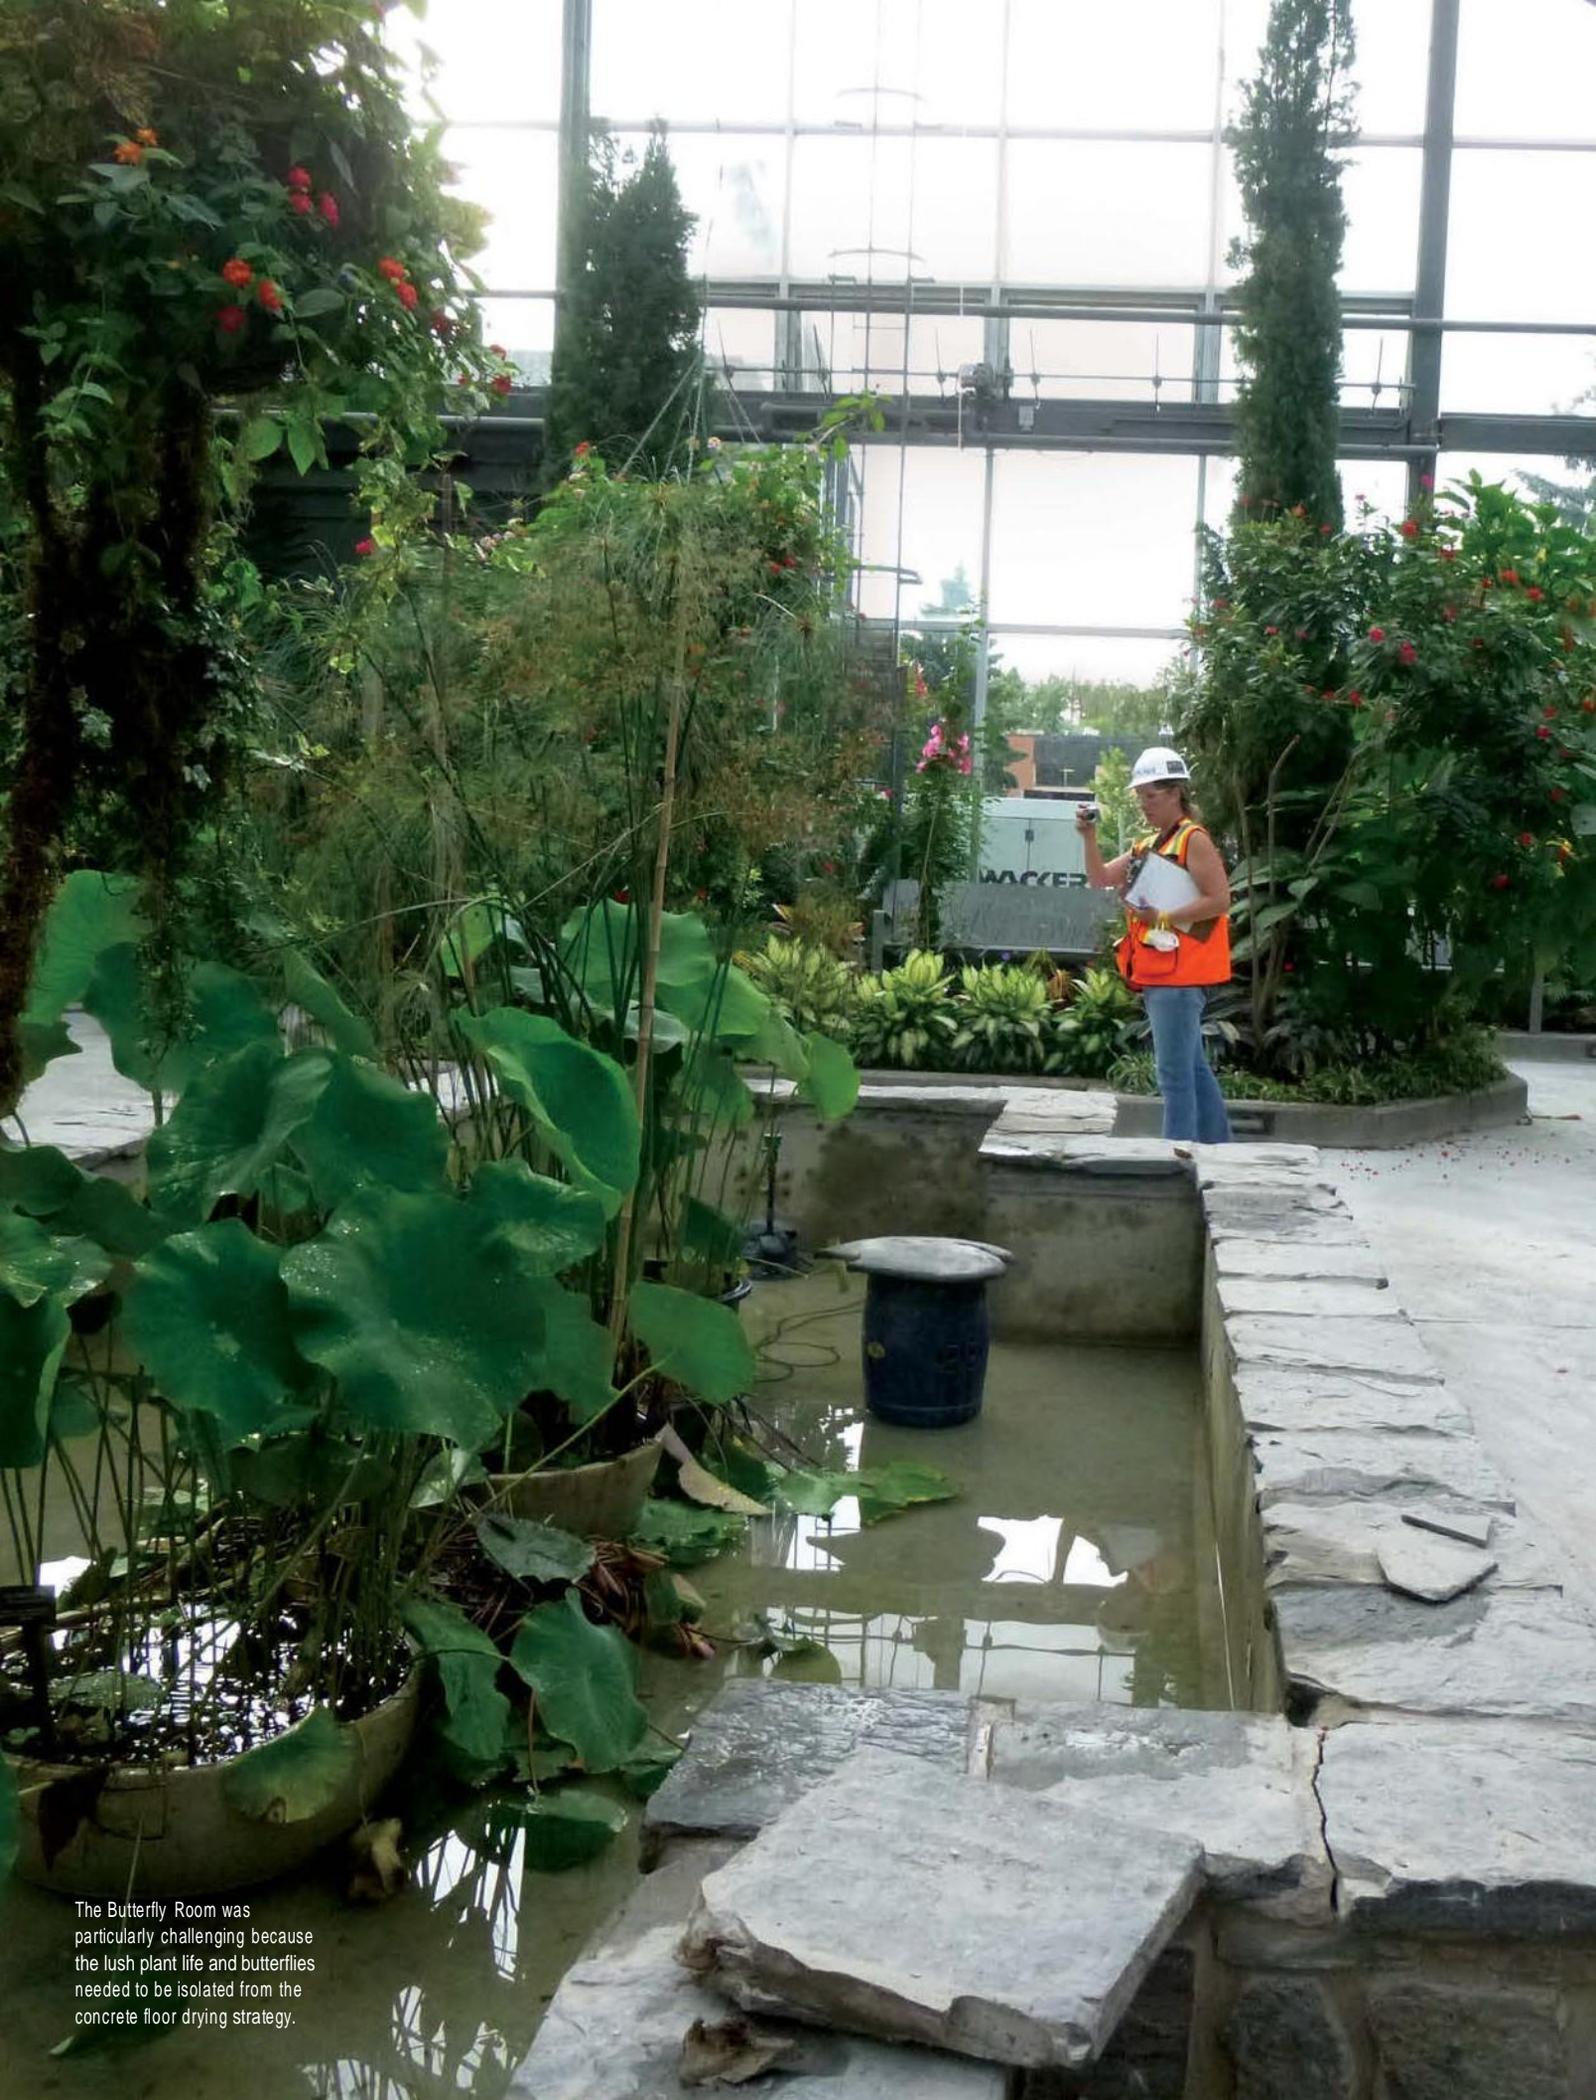
The Butterfly Room was particularly challenging because the lush plant life and butterflies needed to be isolated from the concrete floor drying strategy.

The slate tile floor was removed; the concrete slab required drying prior to tile replacement. The butterflies and plants could not be relocated and the room has a normal relative humidity of between 60 percent to 80 percent, so the concrete slab needed to be isolated from the ambient conditions with a tenting process.
